INSPECTION REPORT

RCRA Subtitle C

Brenntag Northeast Inc.

July 29-30, 2014

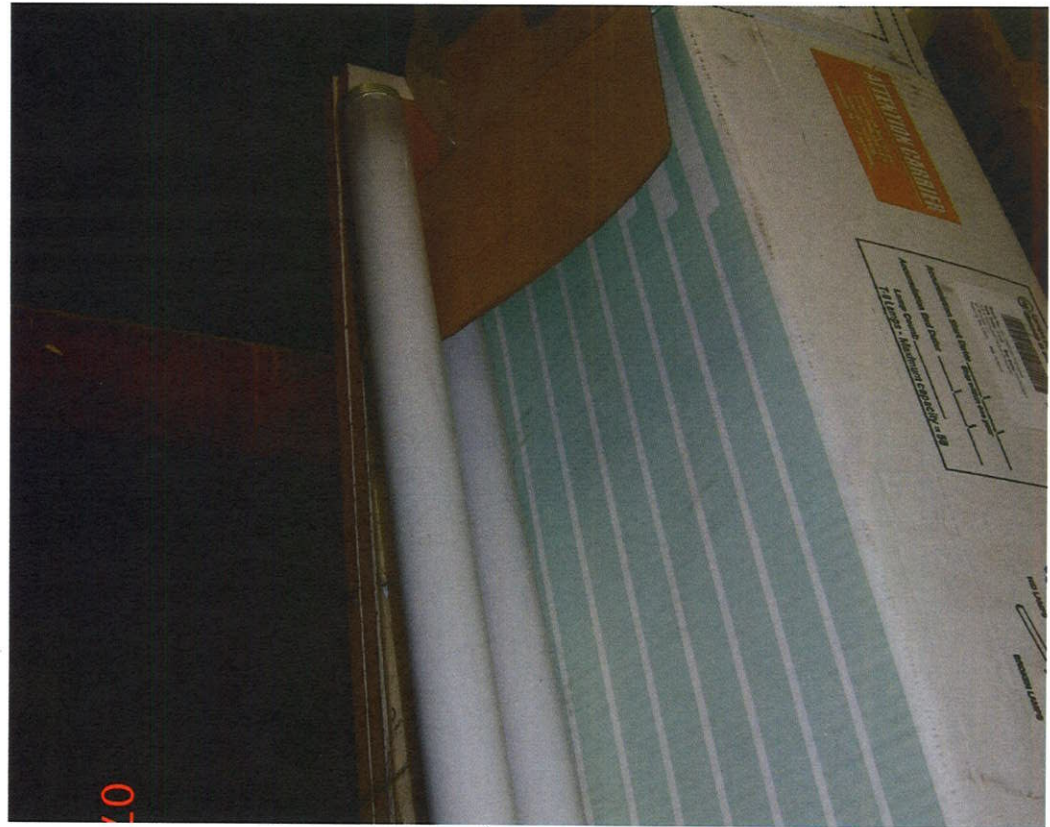
Photograph #23

In the facility's maintenance area, universal waste bulbs were not stored properly and were not dated. Two loosed bulbs are outside of box.

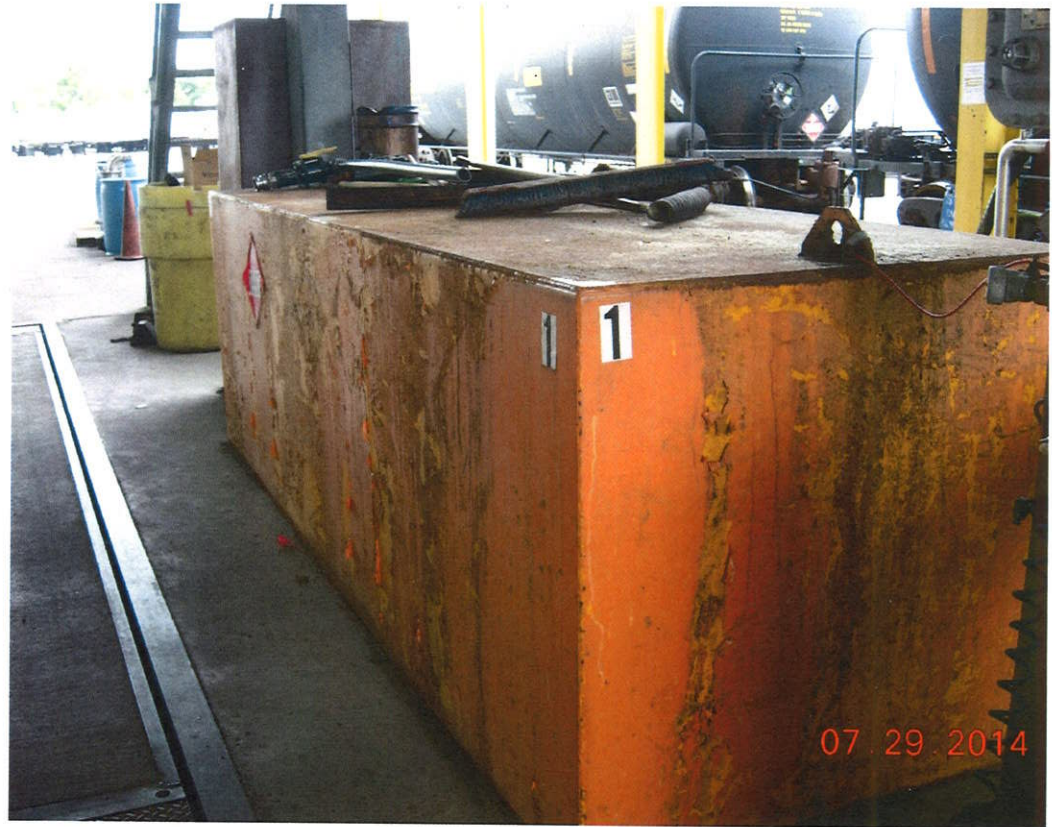
Photograph #24

Finally, the inspectors observed two aboveground steel 3,000-gallon tanks, which the Facility stated was storage for the facility's waste solvents (**Photographs #24 & 25**). These tanks, according to facility personnel statements, were installed in the early 1990's, and are emptied out approximately every 90 days. The Facility generates waste solvents (toluene,

Photograph of aboveground waste solvent tank #1. This is a steel tank with a capacity of 3,000 gallons.

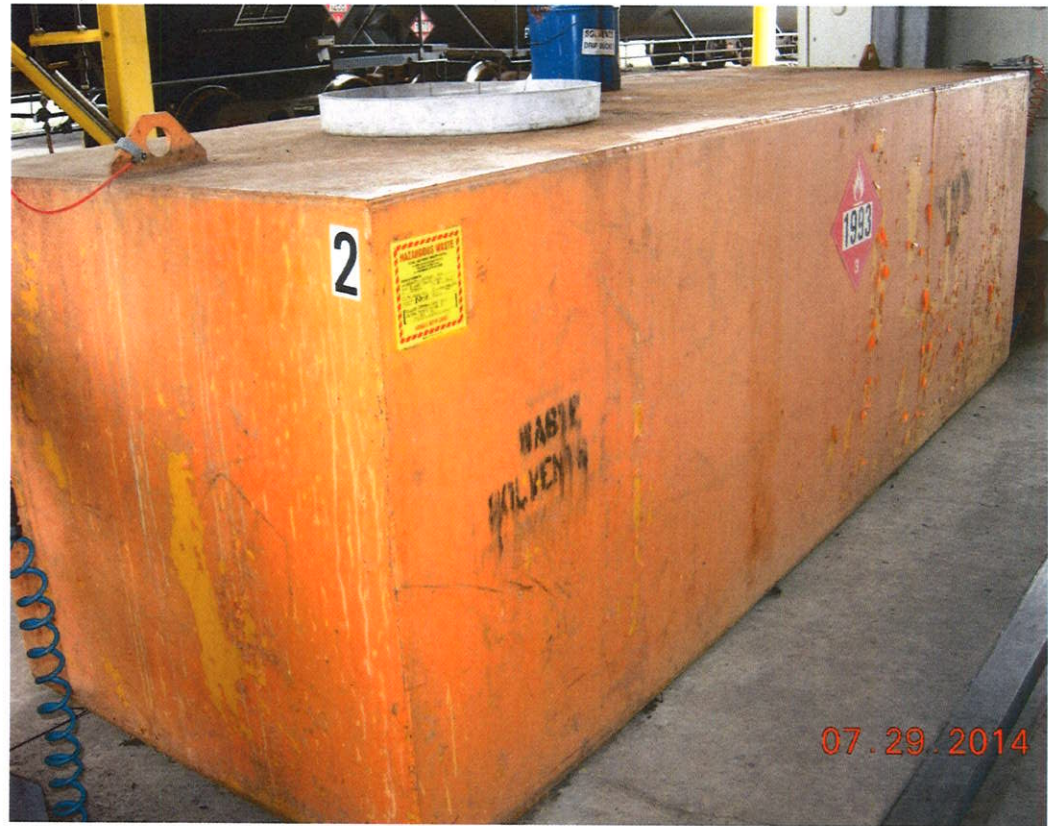
Photograph #25

This is a photograph of the waste solvent tank #2. It is also has a capacity of 3,000 gallons.

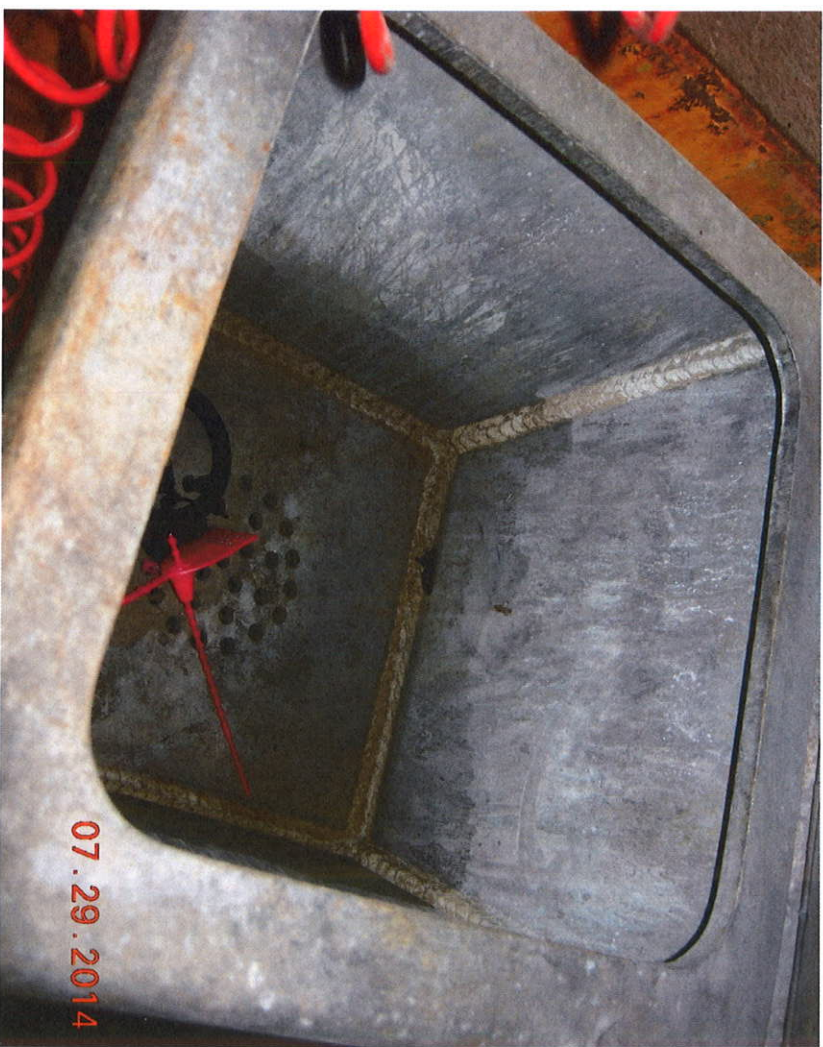
Photograph #27

Photographs #26 & 27). The second photograph was taken after facility staff had removed the top of the funnel. The inspectors asked the facility staff if the waste solvents had a volatile organic carbon (VOCs) level above 500 ppm at the point of generation. The facility staff were not certain if the VOCs levels of the waste solvents were above 500 ppm. The facility did not make an official determination of this waste stream at the time of the inspection. The inspectors asked the Facility if they were subject to RCRA subpart BB/CC requirements. The inspectors requested engineering certifications and manufacturing data on those tanks, but those documents were not available. Facility staff did not know anything about the tanks and their ancillary equipment's compliance with the BB/CC regulations.

The inside of the funnel when it's top is removed.

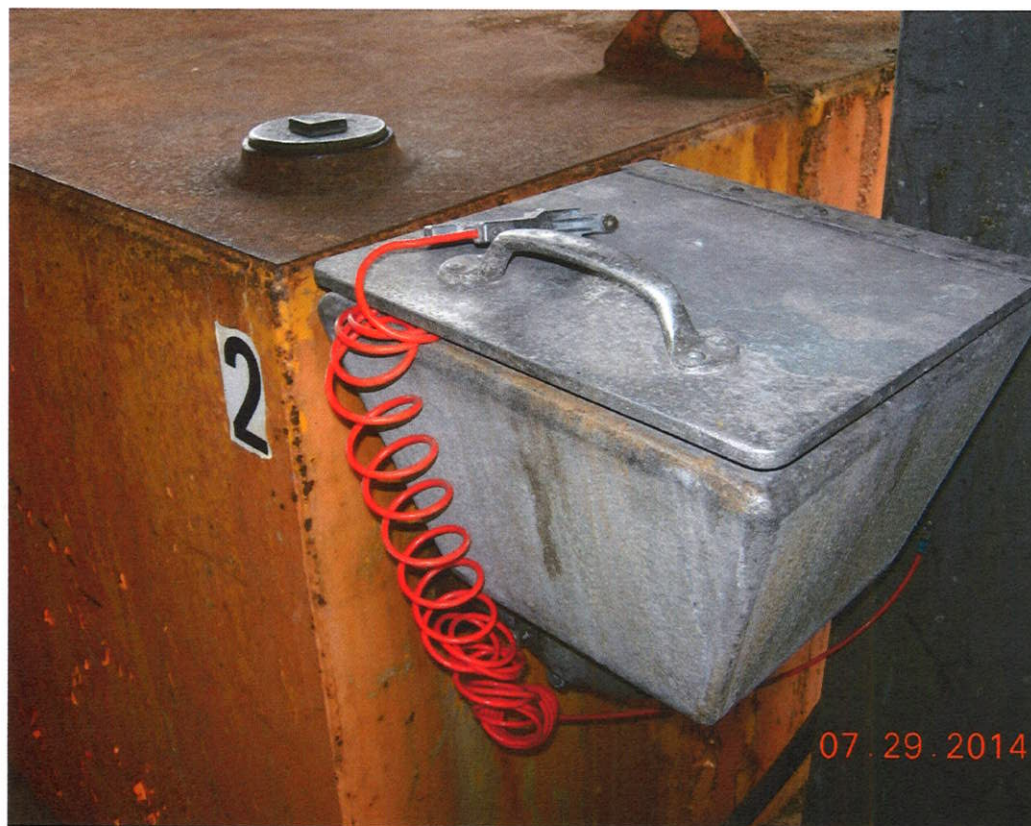
Photograph #26

xylylene, etc.) during their normal operations. The waste solvents from the aforementioned operations were stated to be manually dumped into one of the two waste solvent storage tanks. The inspectors took additional photographs of the funnel that is used to fill these tanks

This is the funnel used by facility staff when adding waste solvents to the tank.
